## Air-Assisted Backwash Breathes New Life Into Dying Filter Beds

The costs of maintaining quality operations in a plant more than a century old called for revamping the system with major filter enhancements.

BY CURT STEFFY AND BILL LADIEU

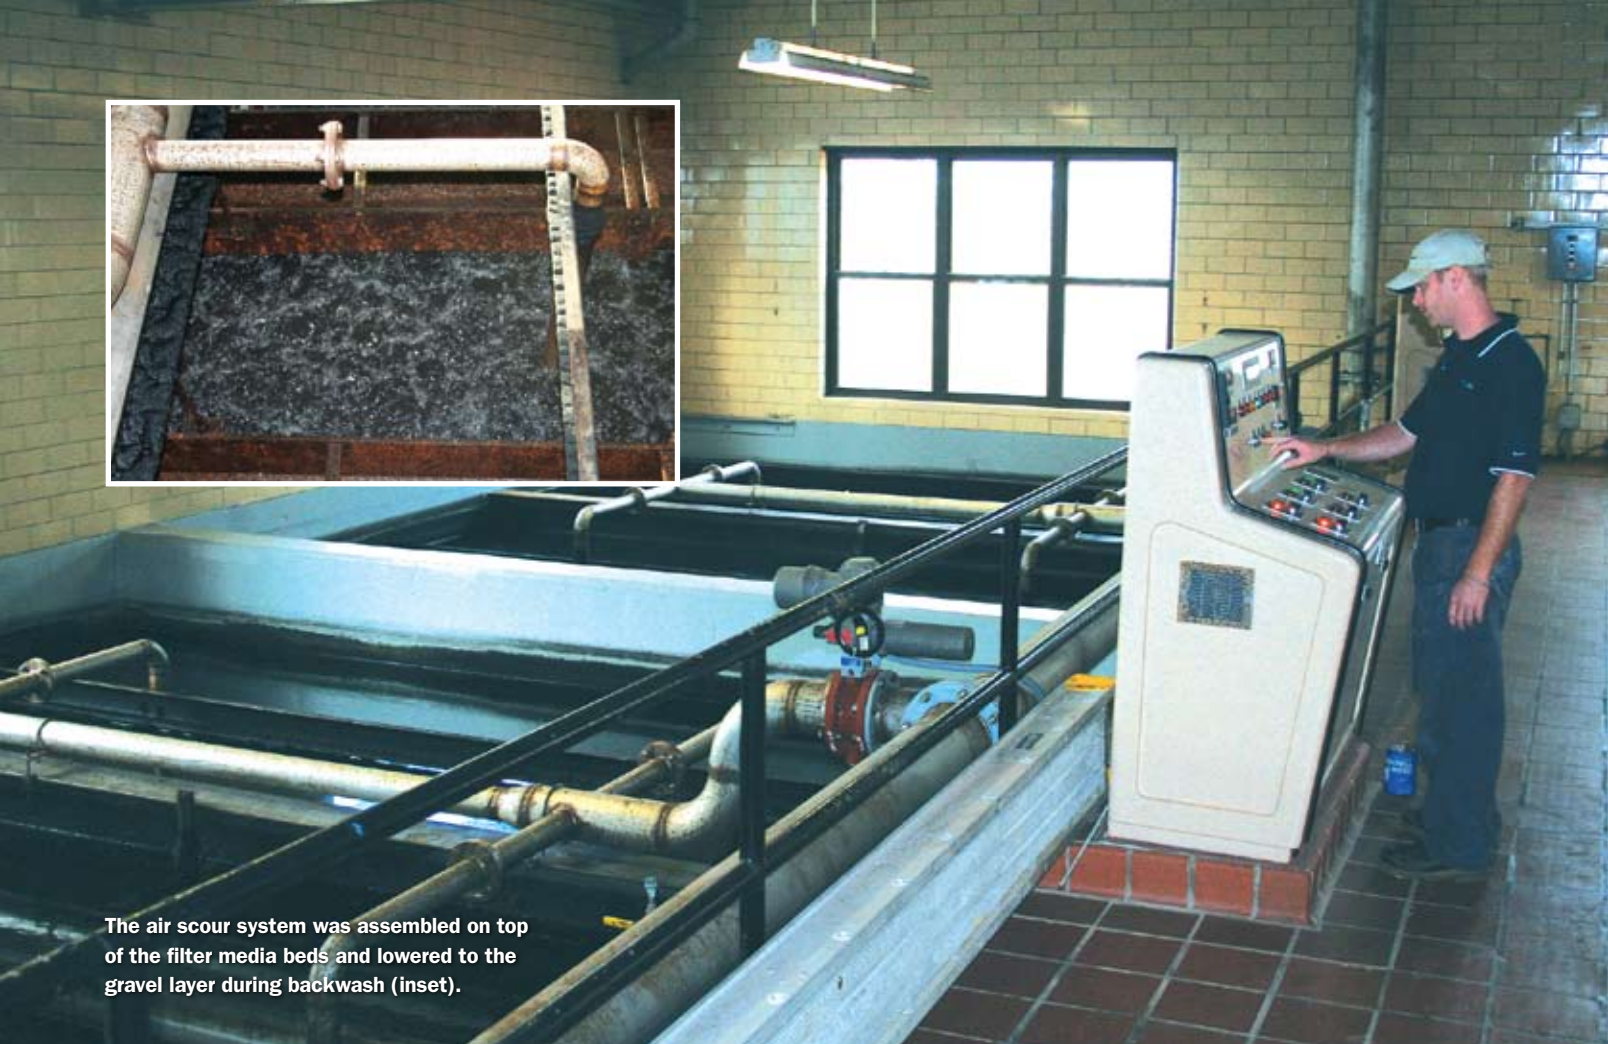
The air scour system was assembled on top of the filter media beds and lowered to the gravel layer during backwash (inset).

Aqua-PA selected a modular air scour system constructed of type 304 stainless steel that allows installation without filter media removal or modification of the underdrain. The air scour system was assembled on top of the filter media beds and lowered to the gravel layer during backwash. Following placement, the grids were bolted into place, and final connections to the air supply headers completed the installation.

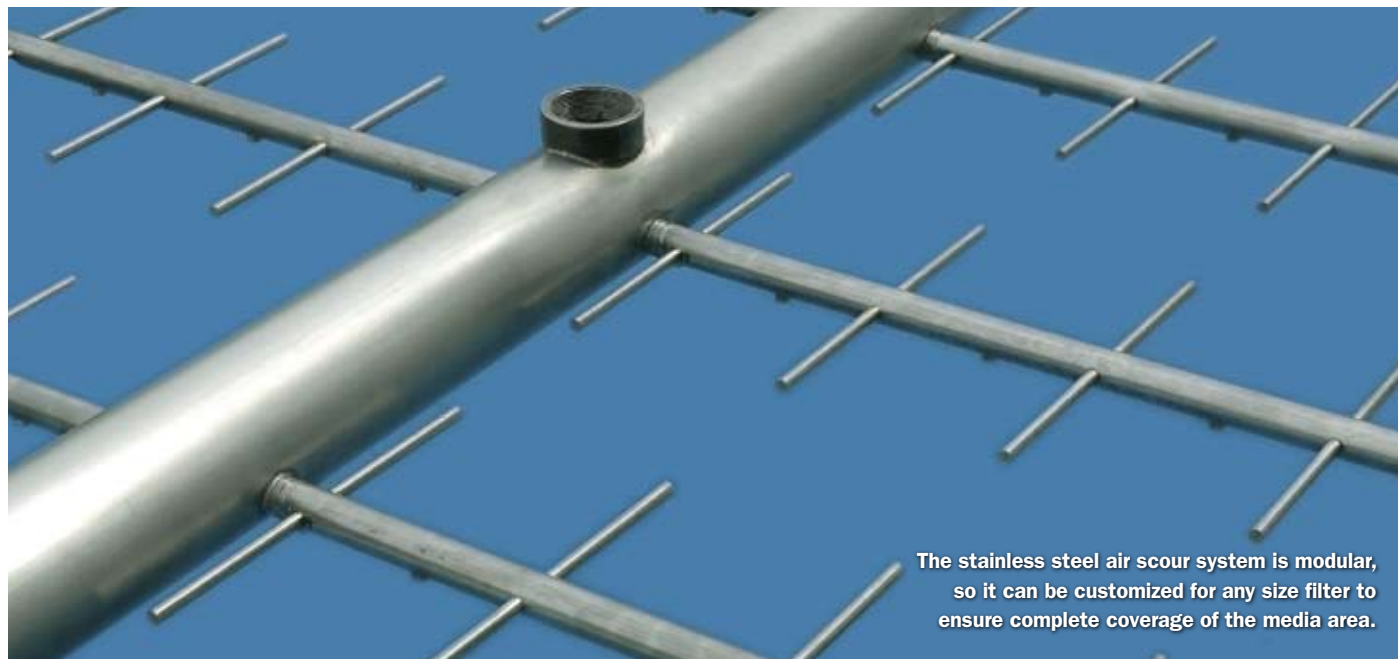
The stainless steel air scour system is modular, so it can be customized for any size filter to ensure complete coverage of the media area.
